NASA TECHNICAL
MEMORANDUM

NASA TM X-53548
November 21, 1966

INVESTIGATIONS OF MONOLITHIC
INTEGRATED CIRCUIT FAILURES

by Kenneth W. Woodis
Quality and Reliability Assurance Laboratory

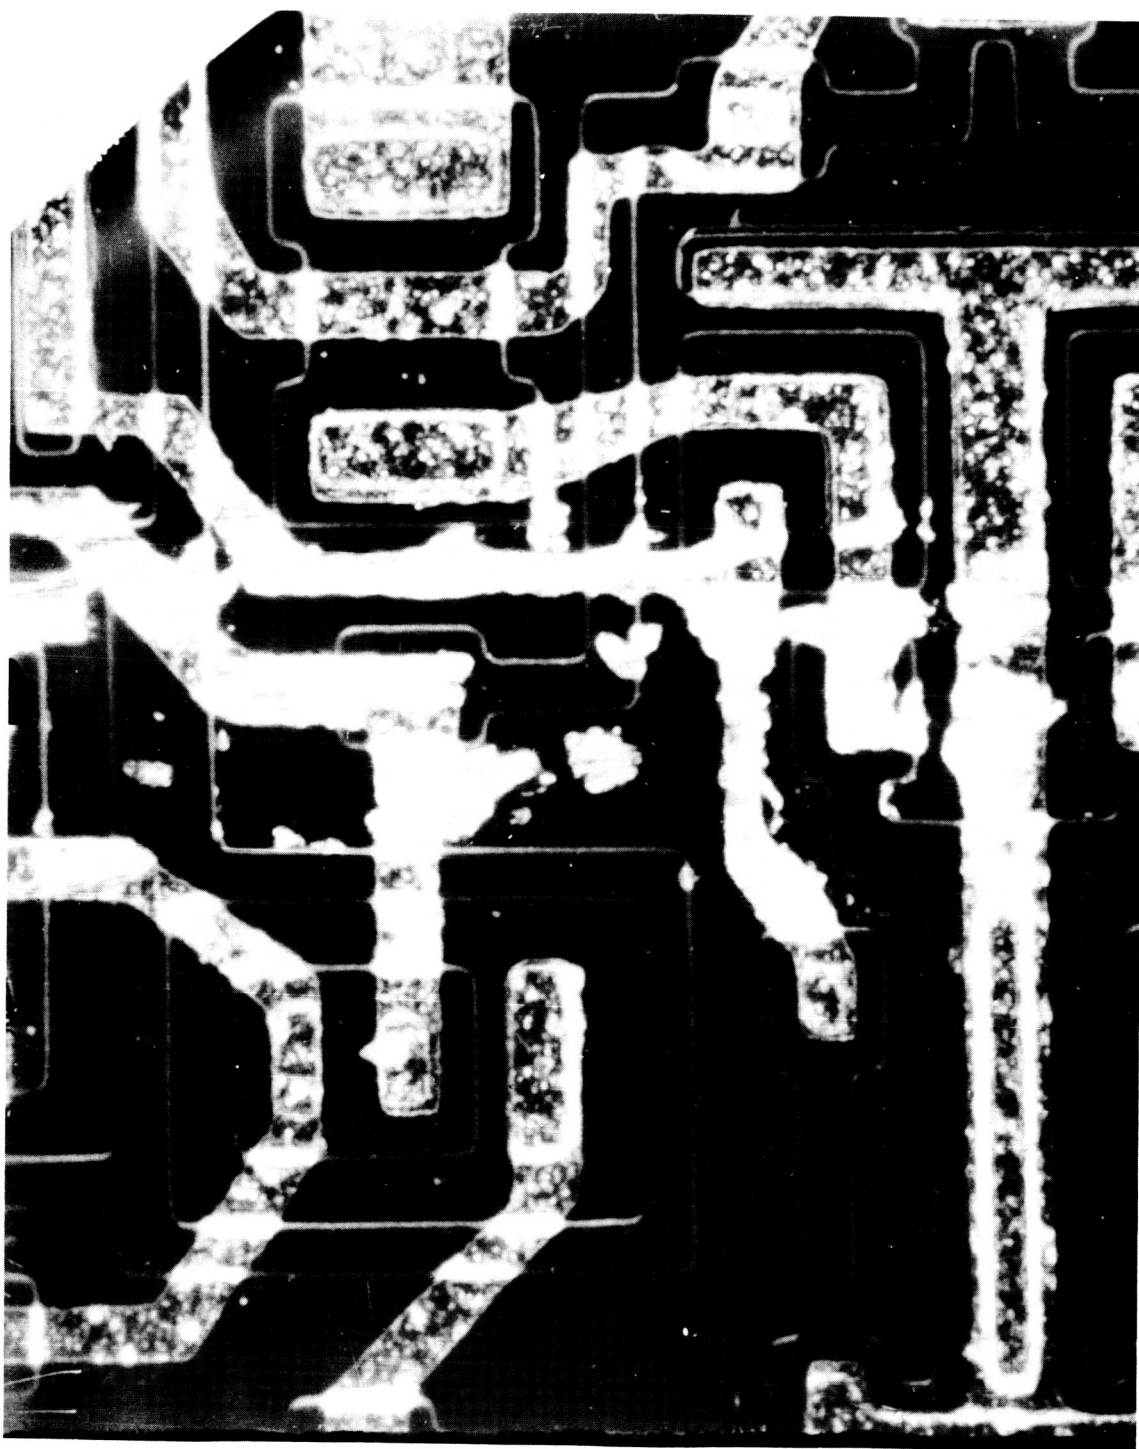
Scarred dice are shown in figures 2 and 3. Note the gouging of the die surface due to operator mishandling. Figure 2 shows a short caused by smearing of aluminum. This short has completely eliminated the function of one of the transistors within the circuit. Figure 3 shows an open circuit due to a tool scratch across aluminum interconnects.

Figure 2. A Short Caused by Smearing of Aluminum

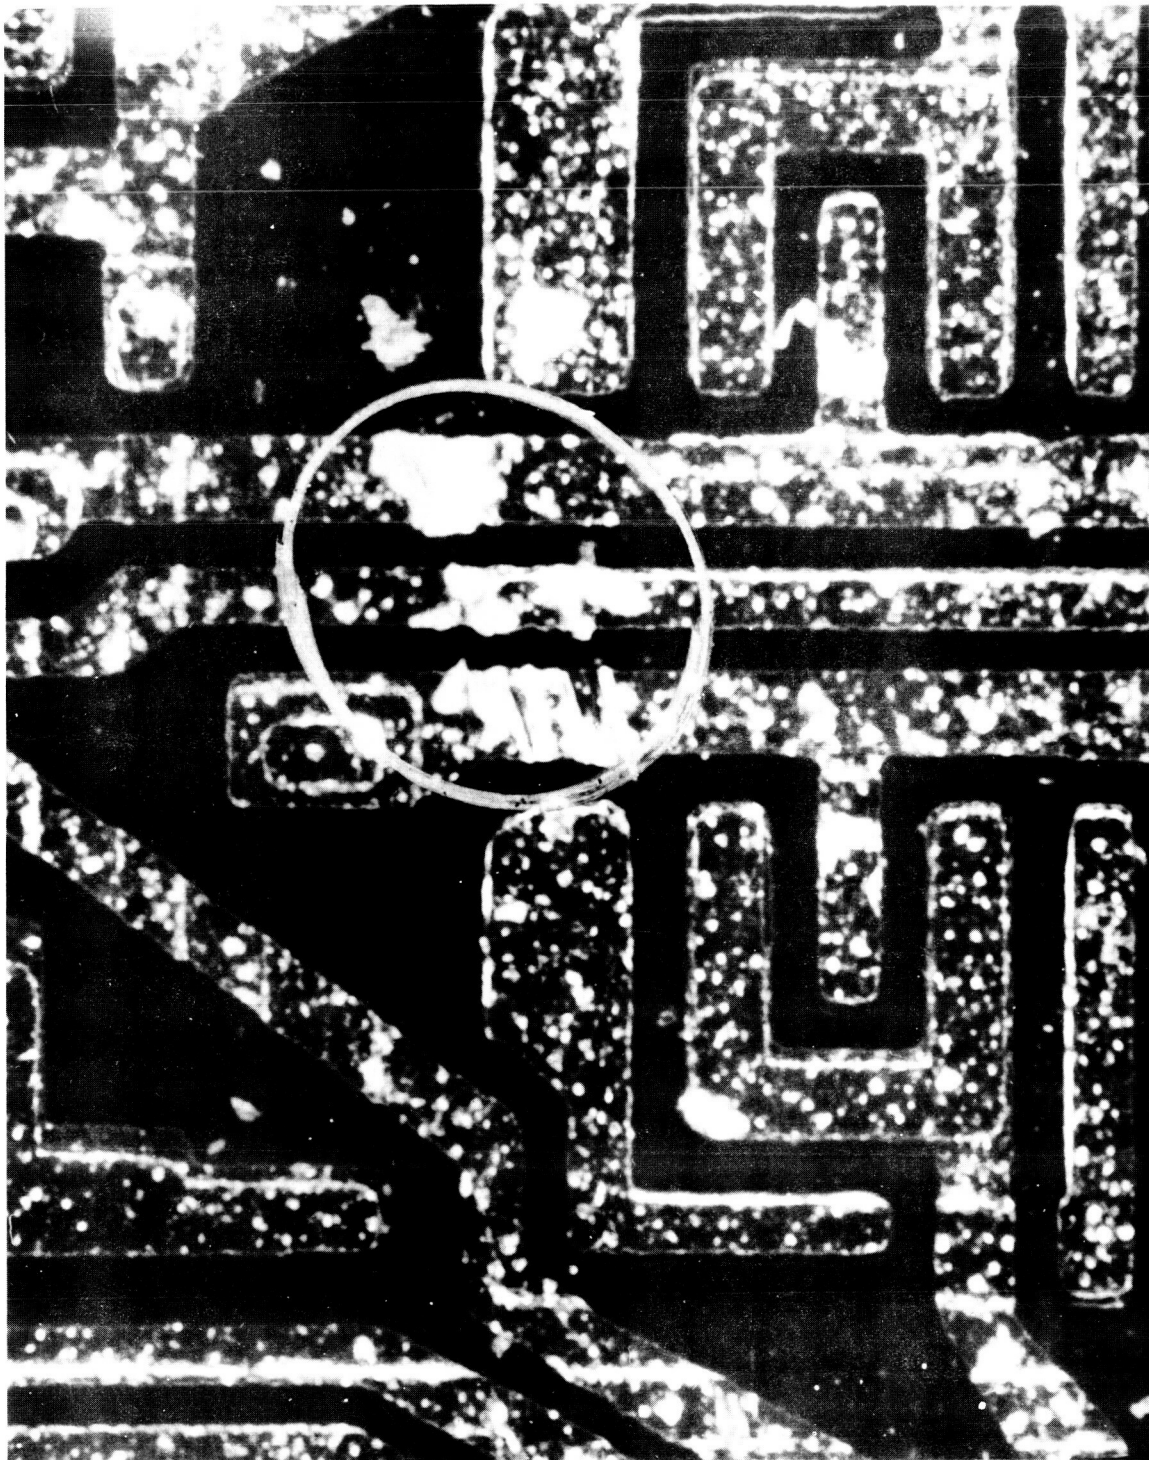
Figure 3. An Open Circuit Caused by a Tool Scratch Across Aluminum Interconnects

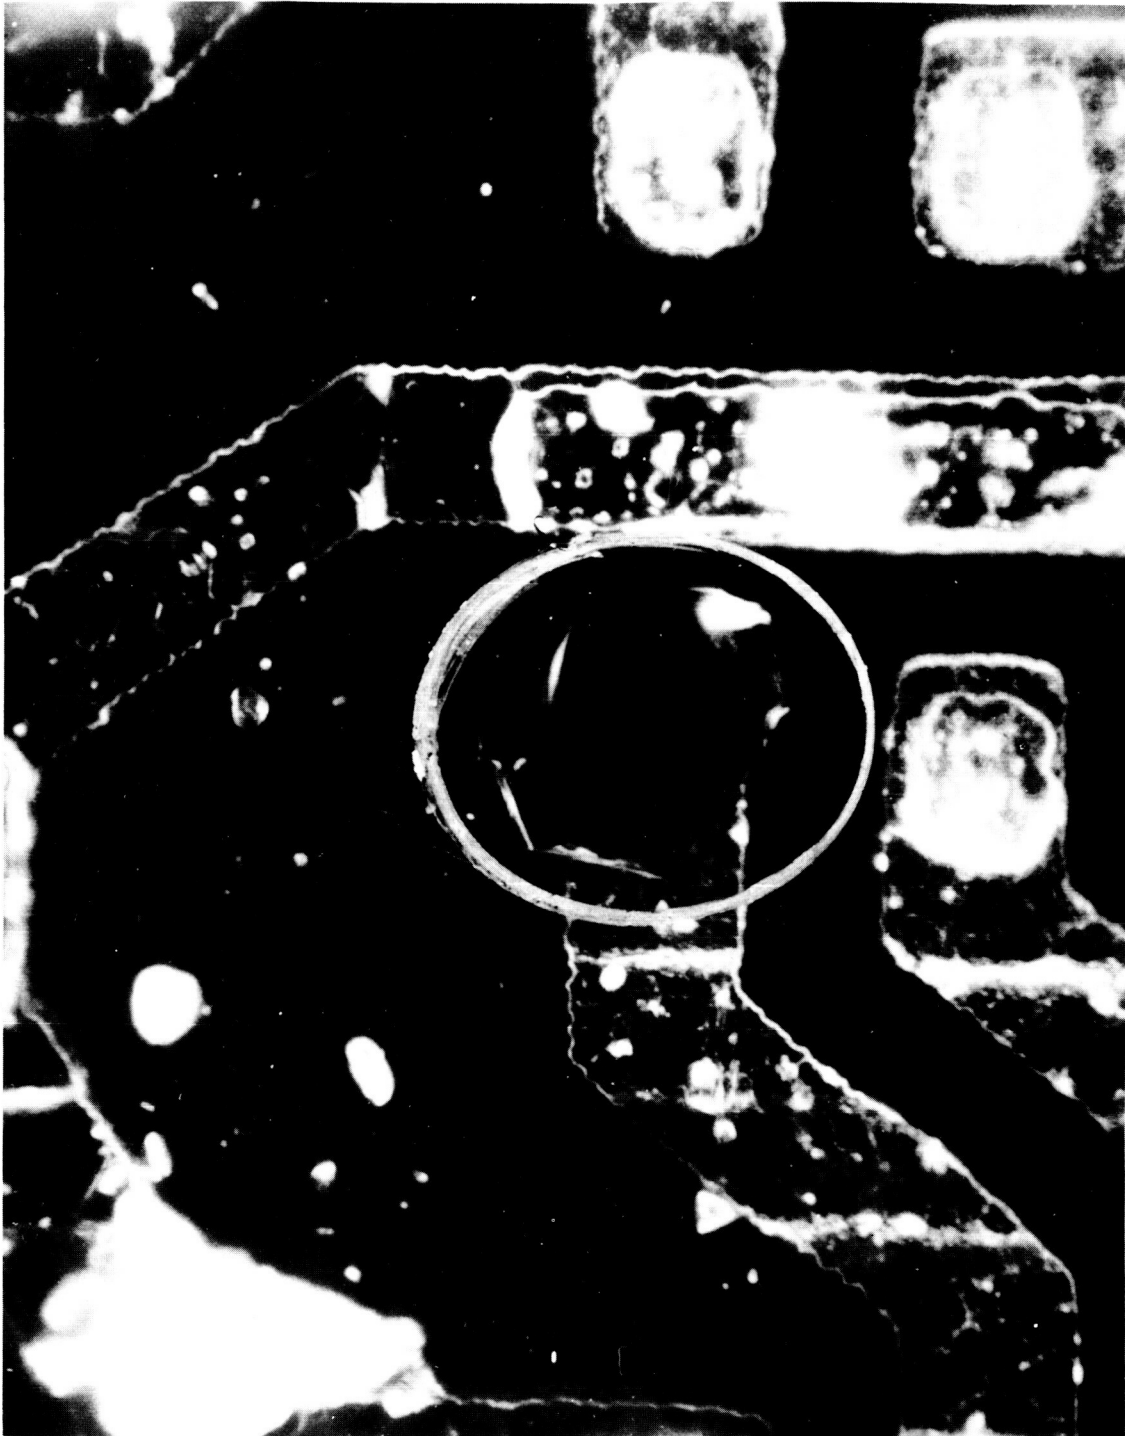
Figure 4 shows a chipped die causing an open circuit. Note that the silicon is completely removed from a contact. Obviously extremely rough treatment was experienced.

Figure 4. An Open Circuit Caused by a Chipped Die

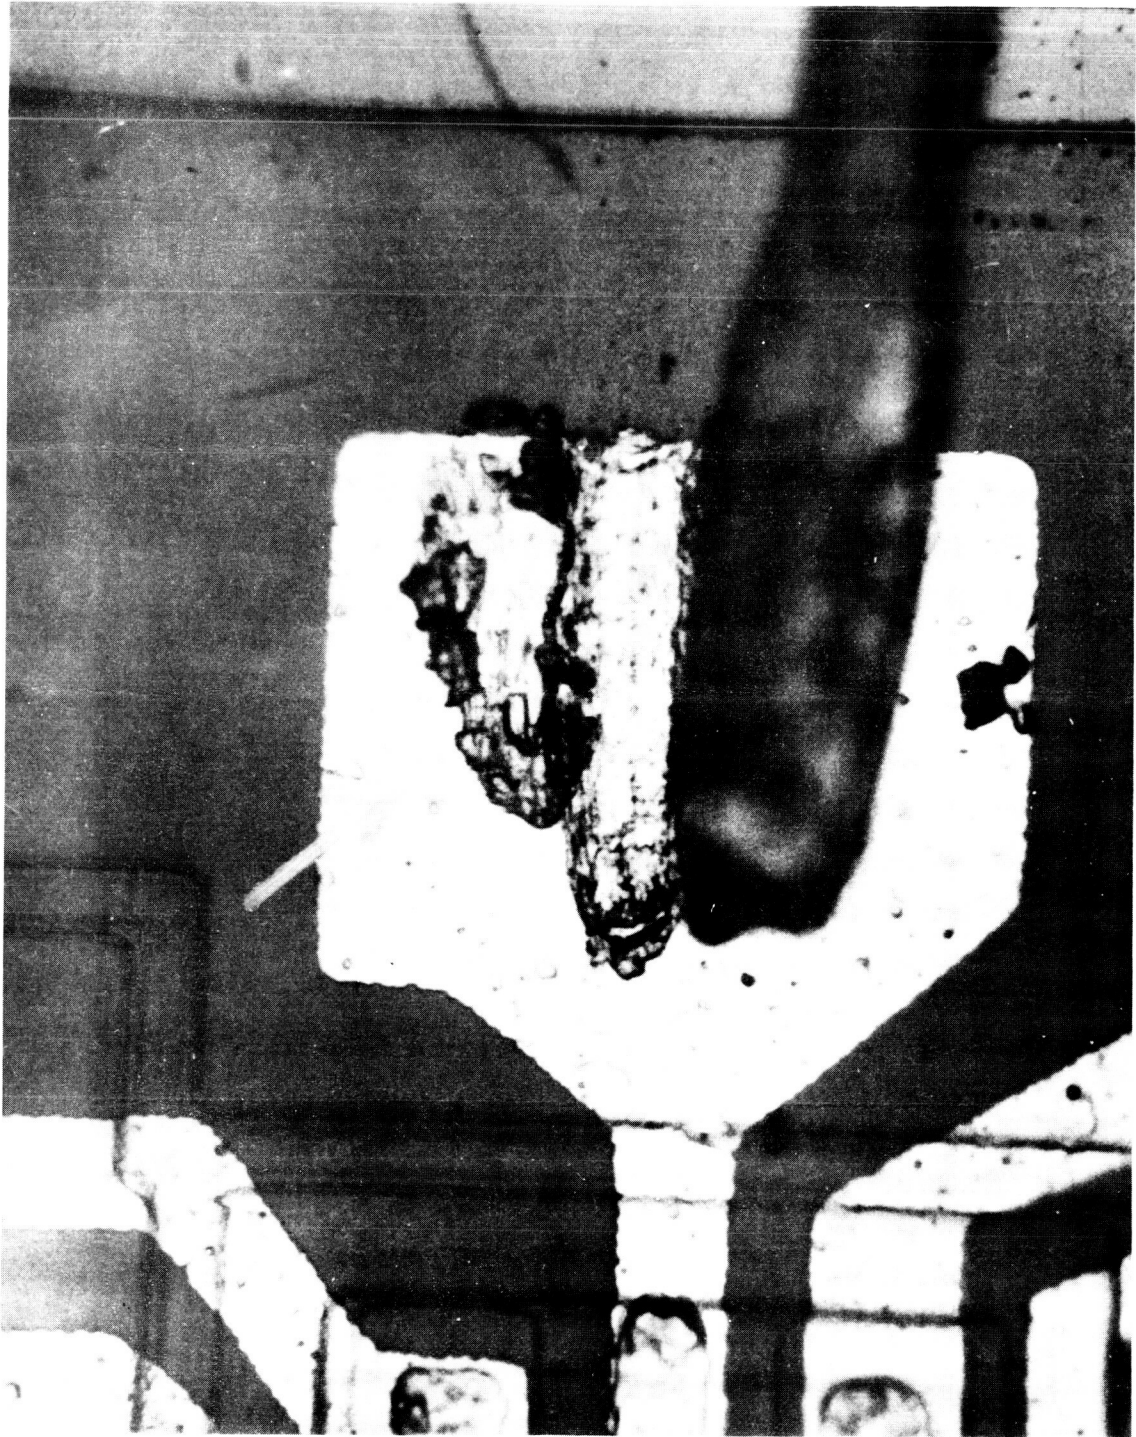
Figure 5 depicts a poorly bonded lead. The bond is a thermo-compression stitch type, and it is obvious by the tooling impressions that at least three attempts were made to accomplish this bond.

Figure 5. A Poorly Bonded Lead

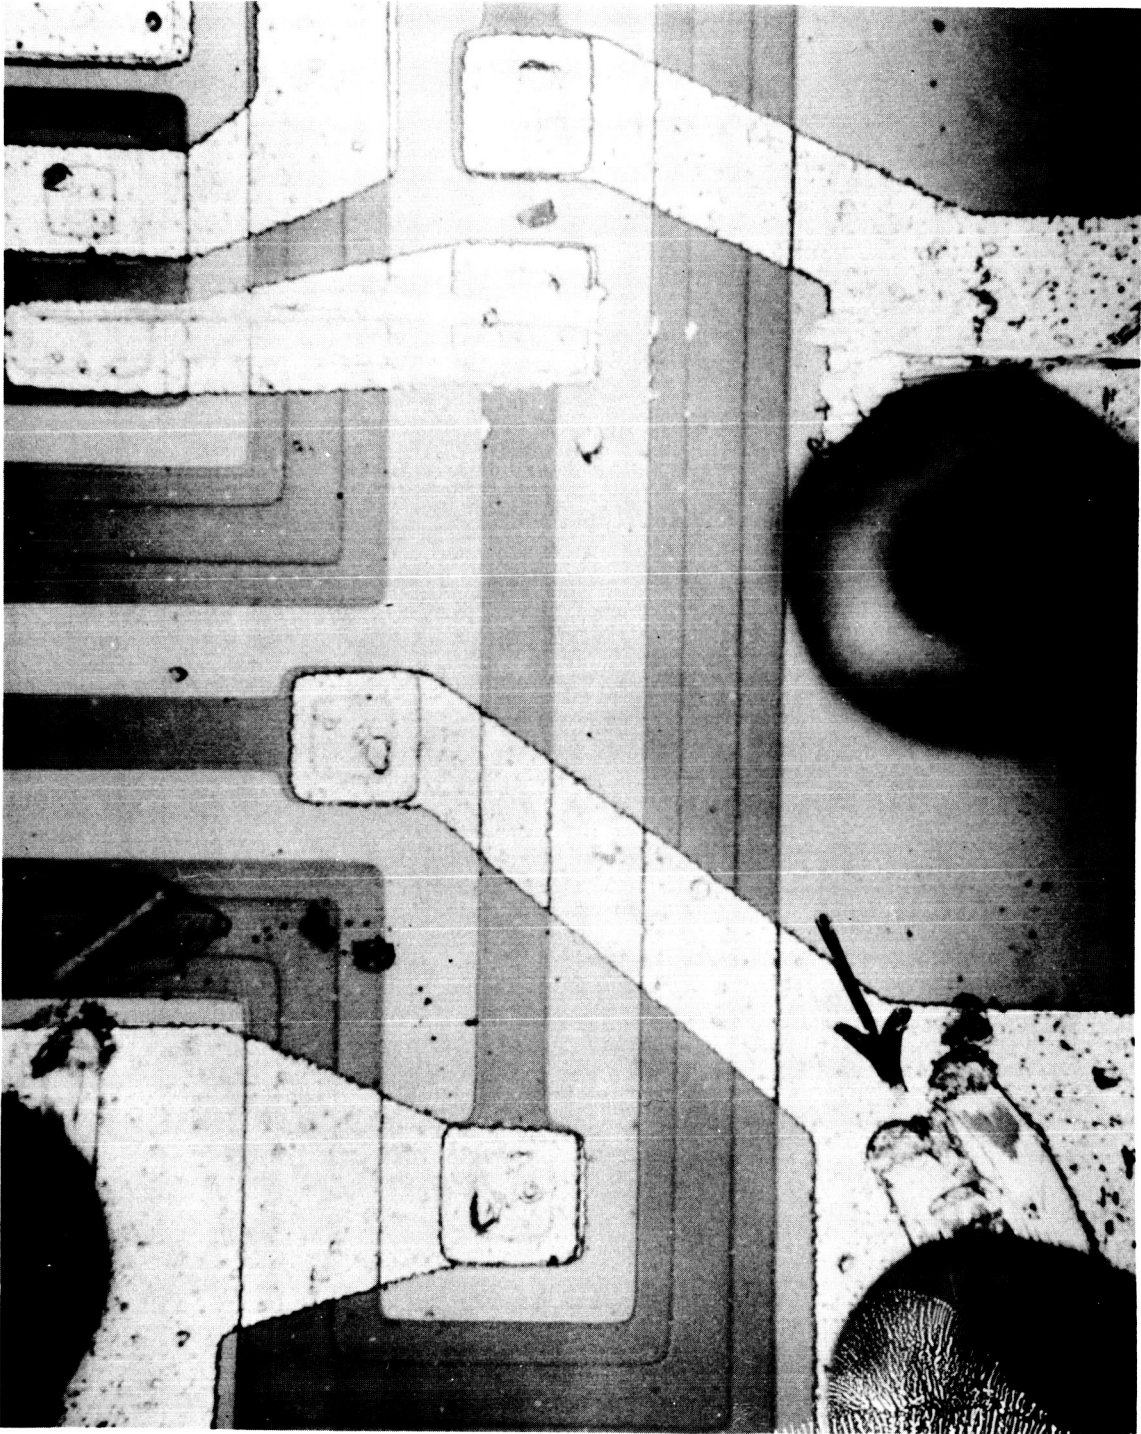
and (c) poor lead bonding. A scarred die similar to those discussed earlier is shown in figure 6. The arrow points to a smear which could cause a poor thermocompression bond, resulting in an intermittent failure. As in DTL NAND, these scars are also due to operator mishandling. Figure 7 shows inconsistencies in deposit thickness, which are probably due to improper control of deposition process.

Figure 6. A Smear Which Could Cause a Poor Thermocompression Bond

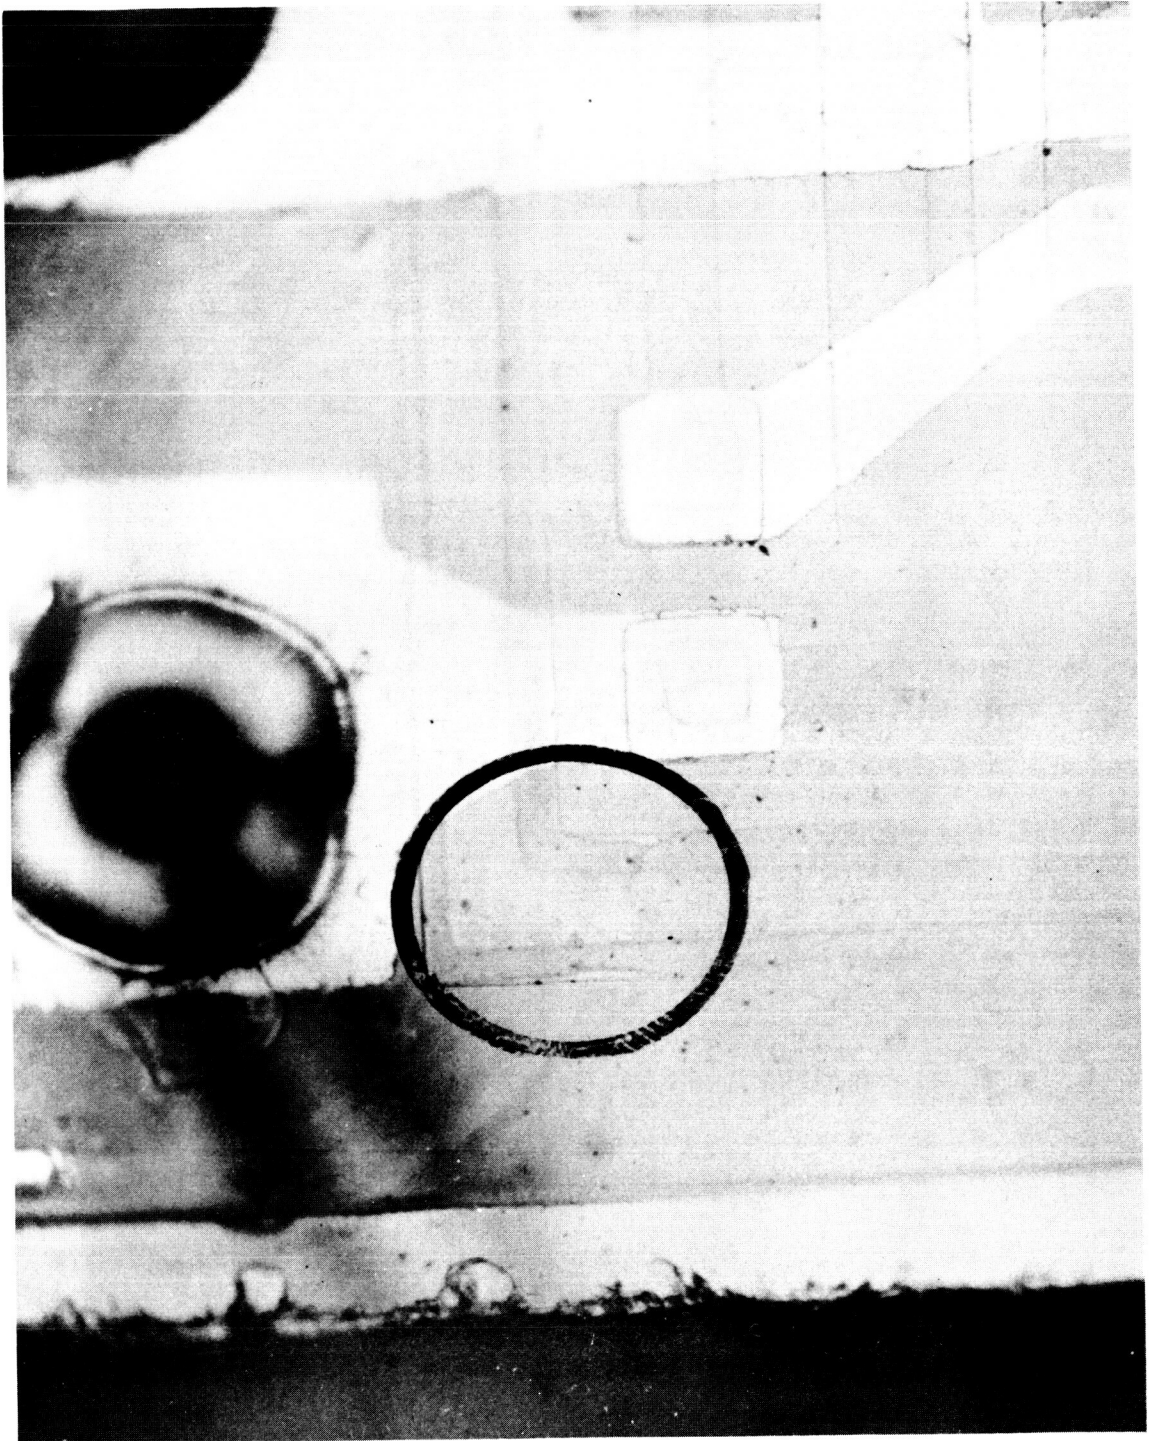
Figure 7. Inconsistencies in Deposit Thickness

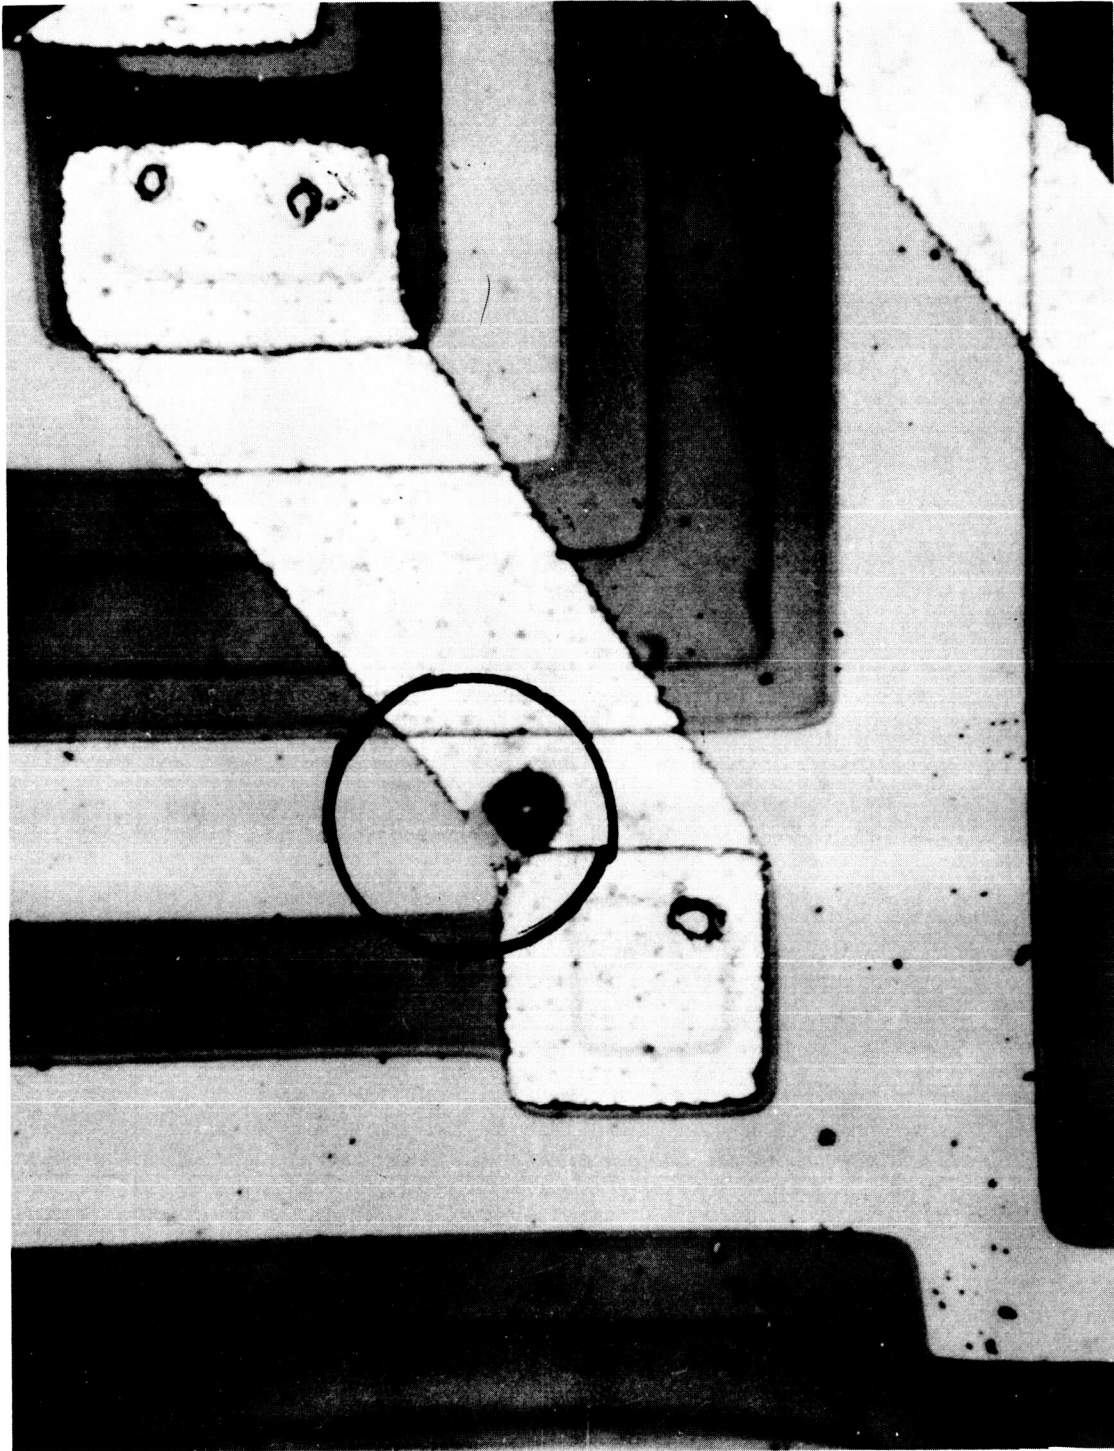
When all of the etchant is not cleaned off the dice, or moisture is allowed to contact the dice, the process of delayed etching takes place as shown in figure 8. Another type of chemical process, not pictured here, is a metallic interaction between gold and aluminum. This causes a highly resistive compound called purple plague. The interaction is accelerated by high temperature.

Figure 8. Delayed Etching

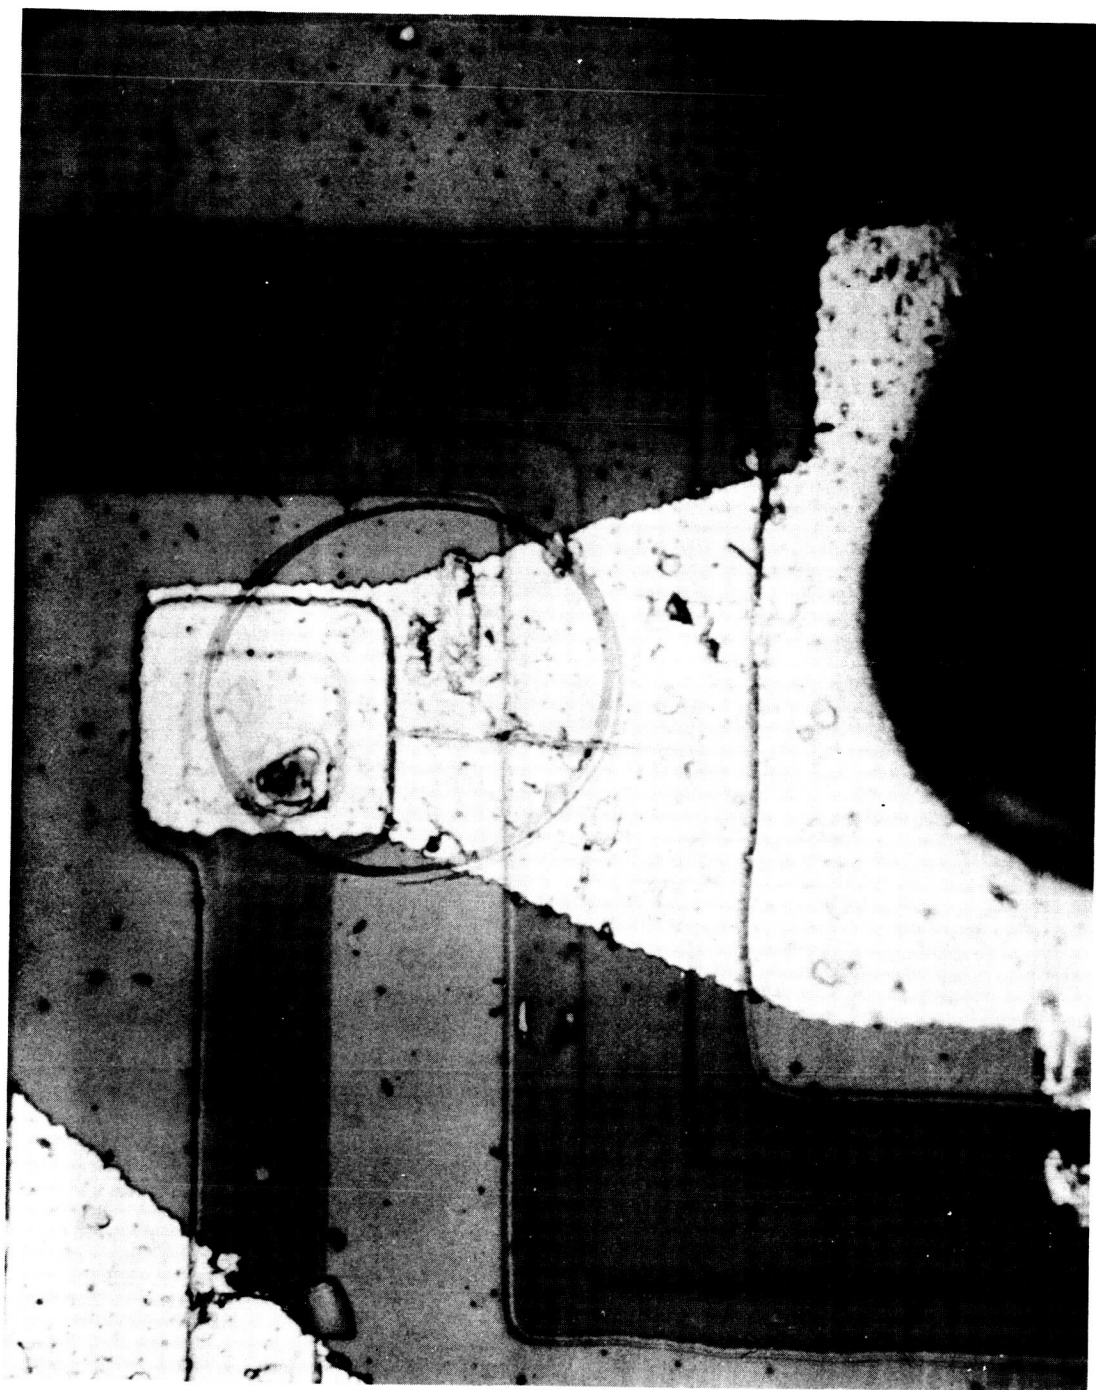
A crack in the substrate at a transistor can be catastrophic but is not as serious in the area of passive elements. This phenomenon is seen in figures 9 and 10; the electrical tests of these units showed them to be good.

Figure 9. A Crack in Substrate

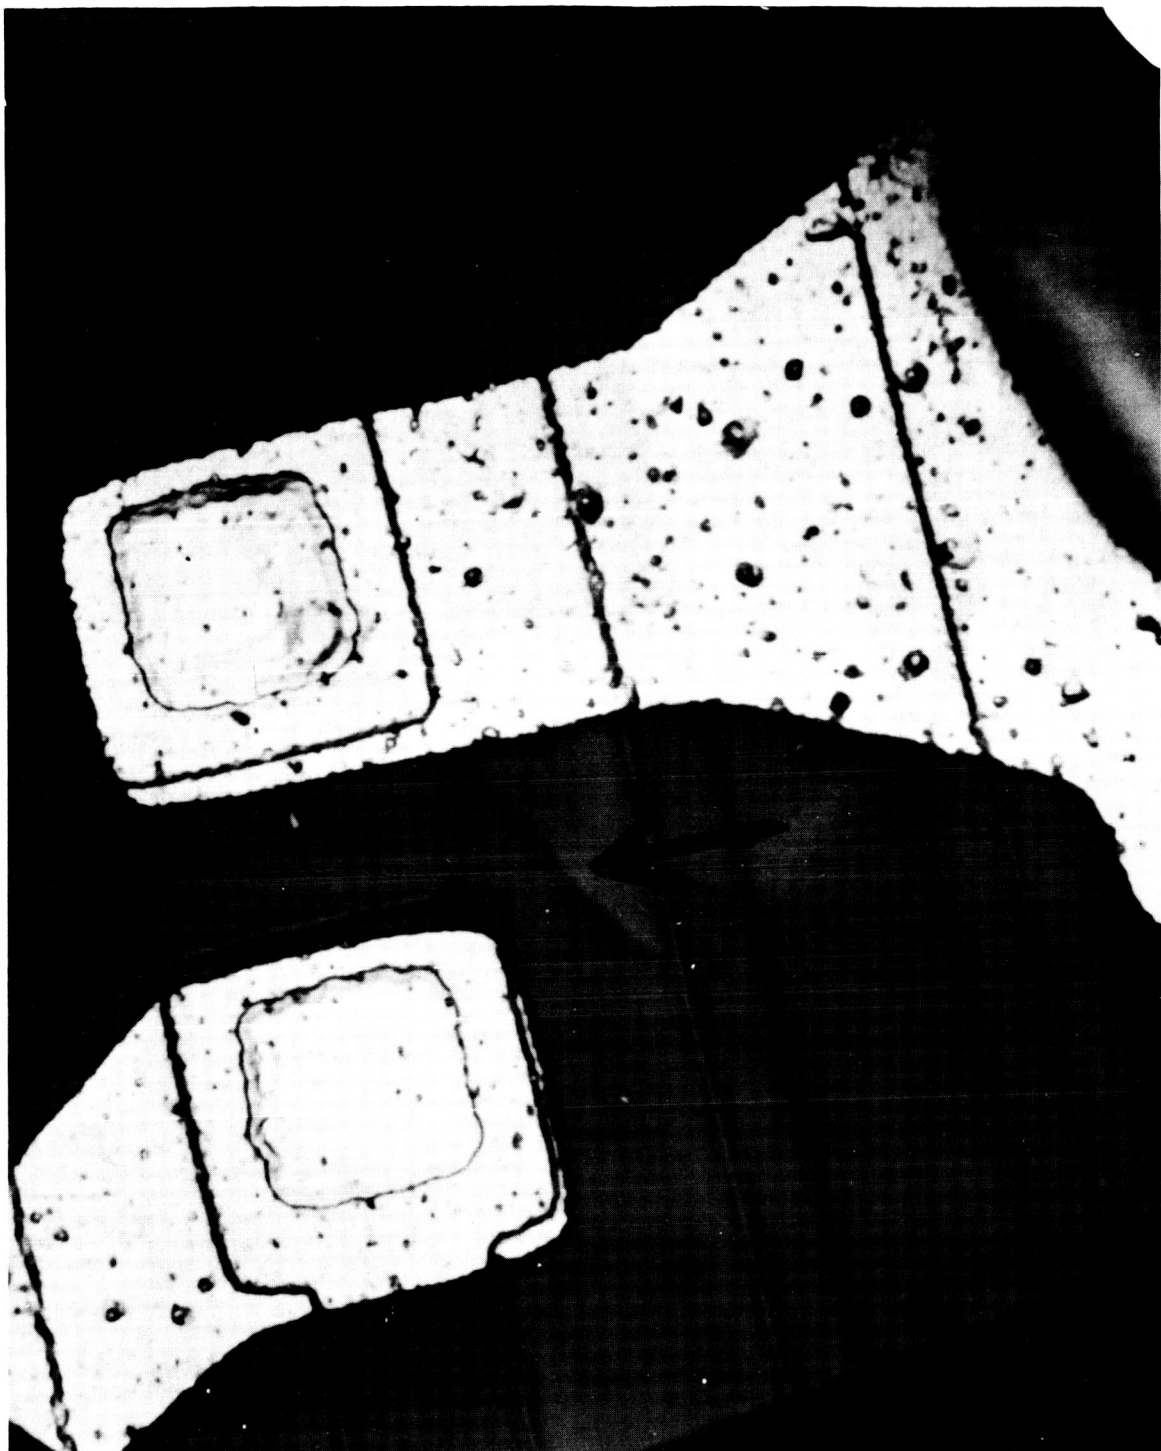
Figure 10. A Functioning Unit Despite Cracked Substrate

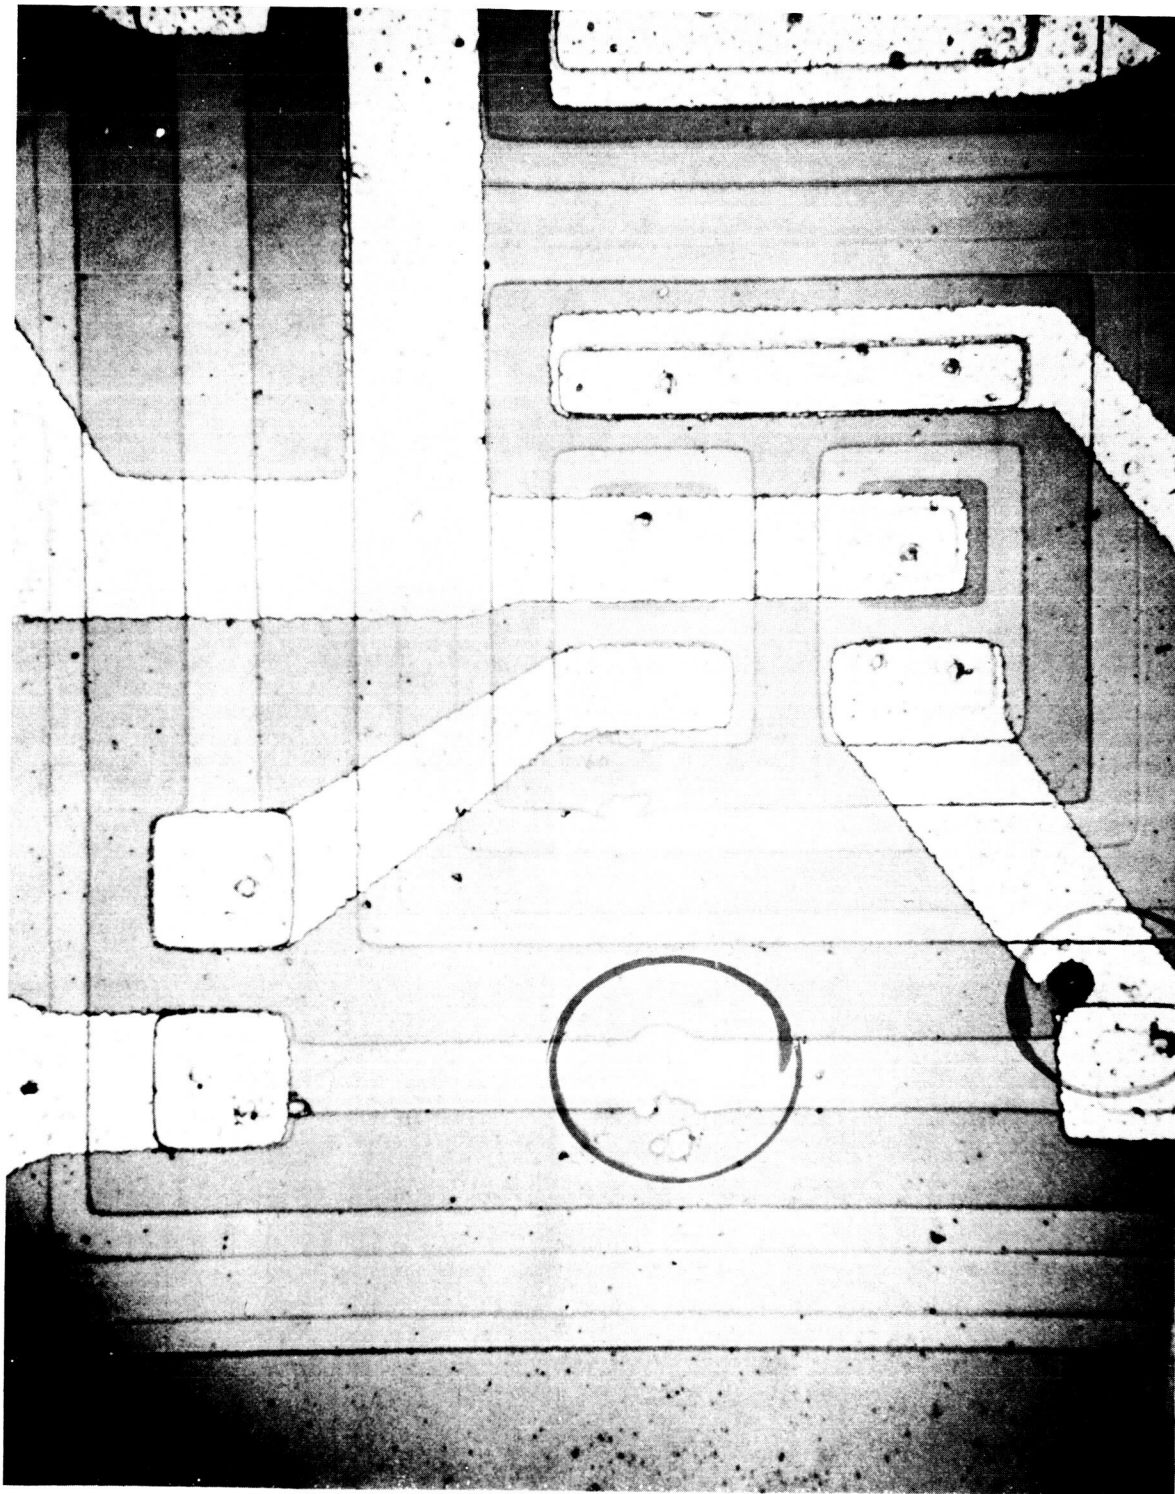
Figures 11 and 12 show passive elements that were not linearly symmetric, which would cause variations in the values of resistance in the item. These variations are caused by improper processing of diffusion masks.

Figure 11. Variations Resulting From Improper Processing of Diffusion Masks

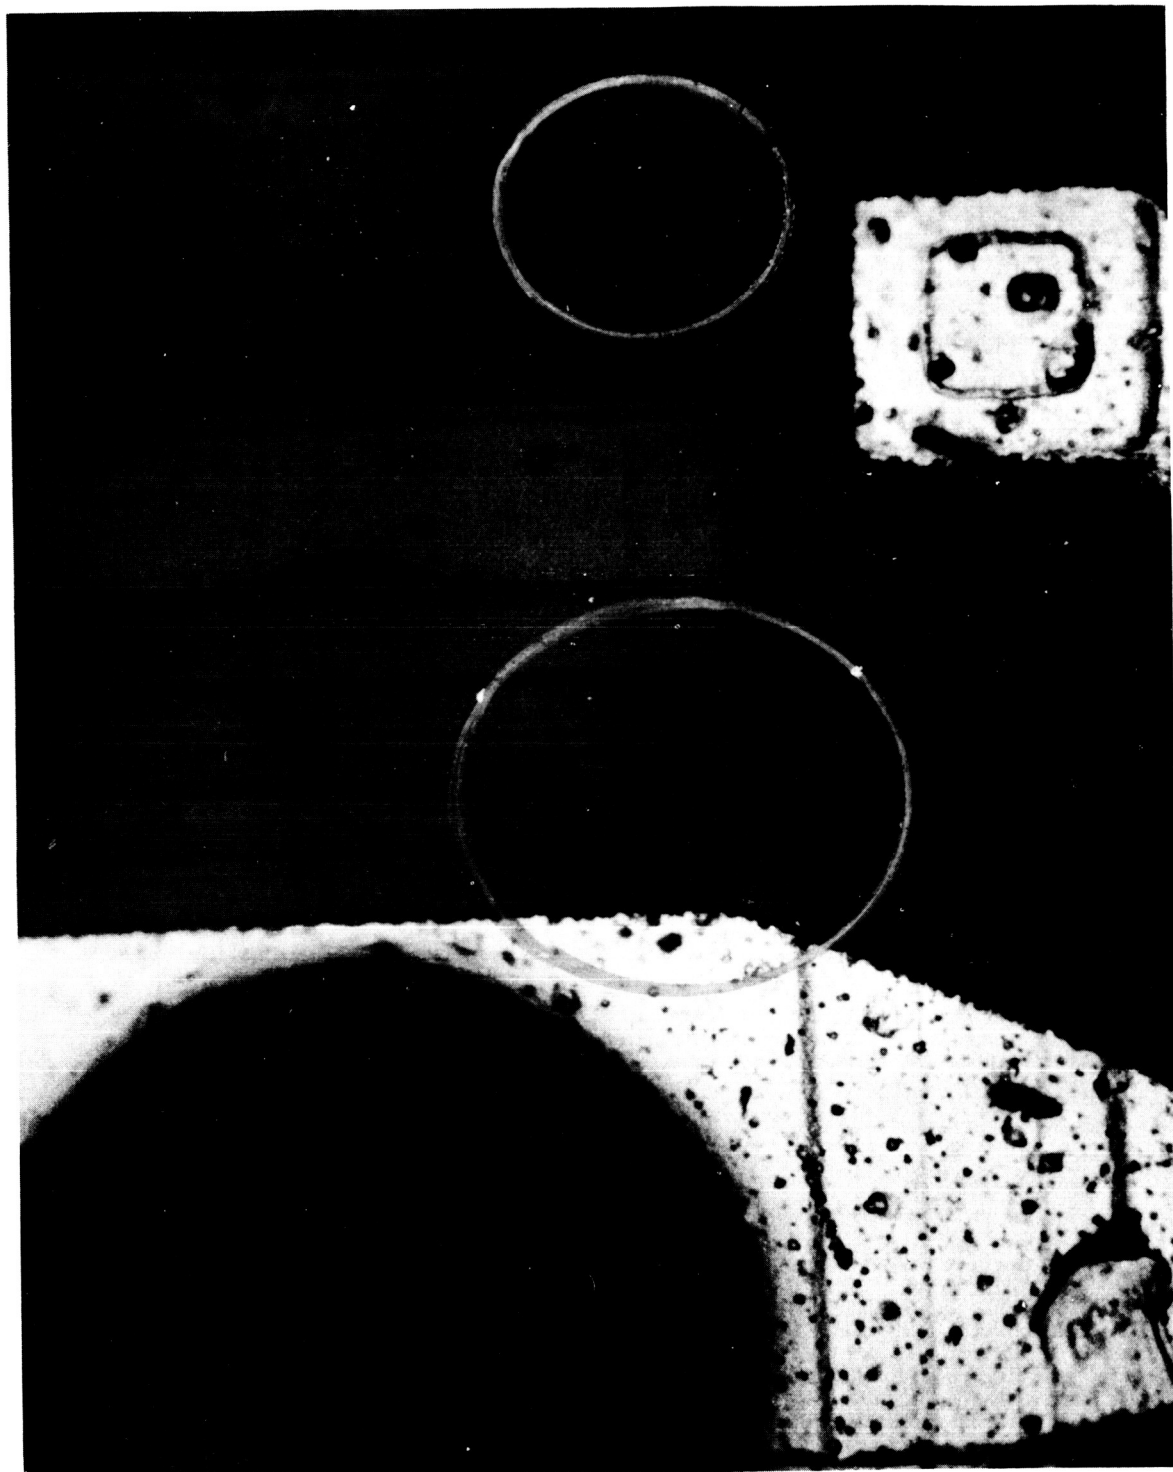
Figure 12. Values of Resistance Altered by Improper Processing of Diffusion Masks

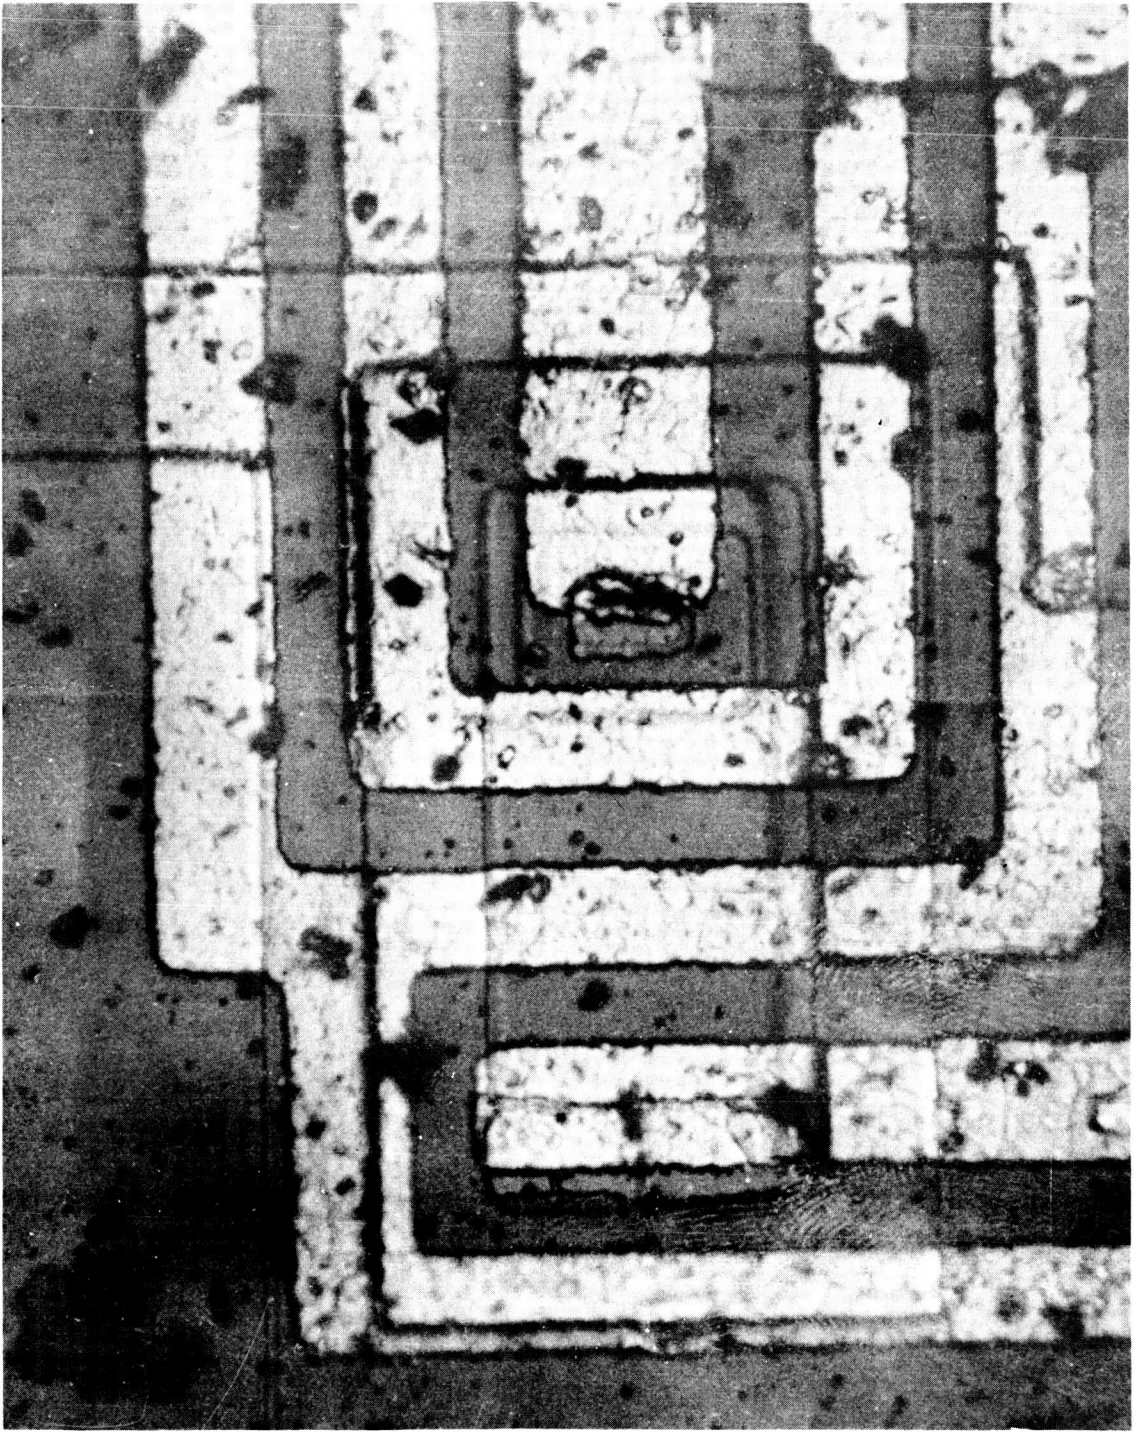
Figures 13 and 14 present errors caused by a faulty mask or mask positioning. Notice that the aluminum lead in the middle of figure 13 was covering less than half of the bonding pad. The two diodes in figure 14, which have a common lead, had each end of this lead bonded to two layers of different heights; thereby shorting the diode to a lower layer of the circuit.

Figure 13. Aluminum Lead Covering Less Than Half of the Bonding Pad

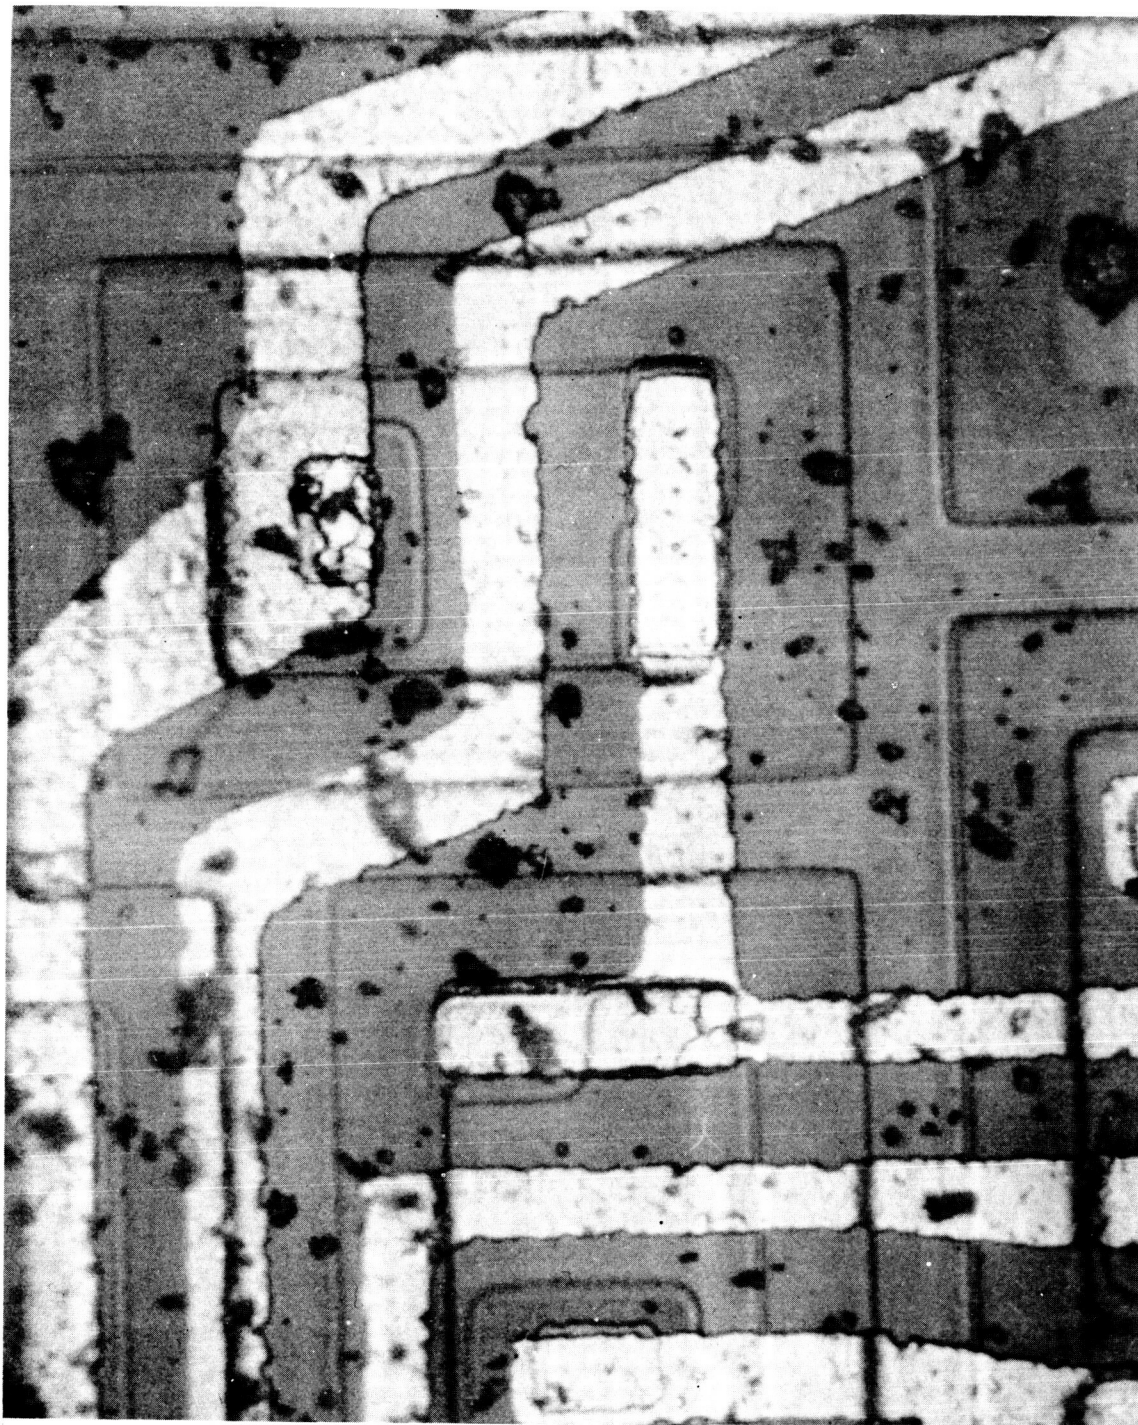
Figure 14. A Short Caused by Faulty Mask Positioning
